## GSE Technical Bulletin

### SUBJECT: Firmware Issue – Current Sensor Time Out

This bulletin is to communicate a firmware issue which could affect GSE batteries made prior to February 1<sup>st</sup>, 2019.

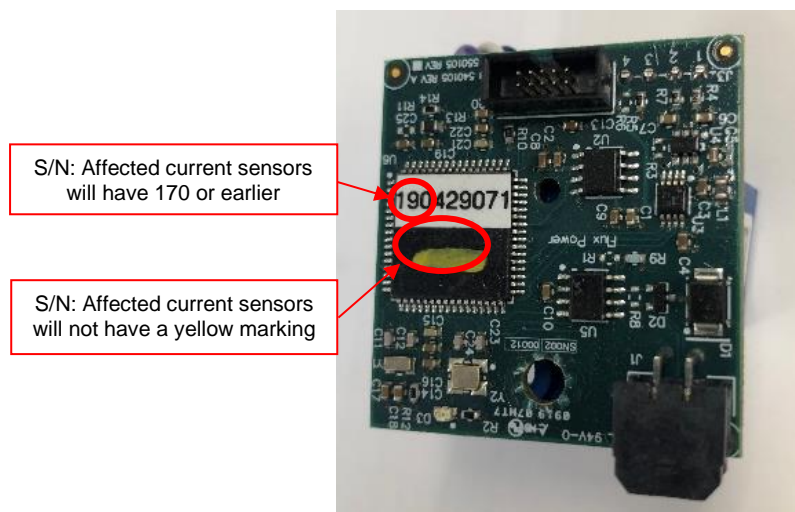
GSE batteries shipped before February 1<sup>st</sup>, 2019 are affected if:

- The current sensor does not have a yellow marking.
- The current sensor has a serial number that begins with 17 or earlier.

In the event of the above symptom being observed, contact Flux Power to receive a service kit (P/N 200121) and connection package. Once the kit is received, use the following instructions to implement the fix.
