Modular Systems Technical Bulletin**SUBJECT: Modular System Fastener Replacements**

This bulletin is intended to communicate a hardware kit that provides a solution for an issue that has been identified in modular system fasteners.

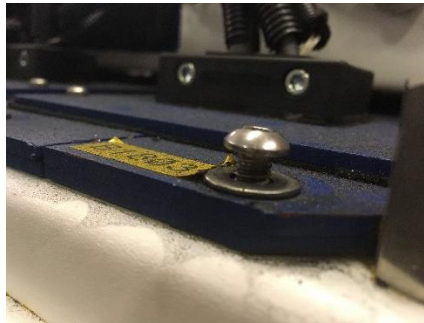
Some Class 1 and GSE batteries have a hardware issue where the blade fasteners under the top cover can loosen, as shown below. This issue can be repaired in the field with a service kit provided by Flux Power.

Class 1 and GSE batteries shipped before January 1st, 2019 are at risk of this failure.

In the event of the above symptom being observed, contact Flux Power to receive a service kit. Once the kit is received, use the following instructions to implement the fix.
