Technical Bulletin

X36 BMS 1.0 Charge Contactor Lock OPEN

This bulletin is to notify the user of Flux Power X36 Battery Management System (BMS) 1.0 so they can be aware and know how to address this bug that is preventing packs from charging on the field.

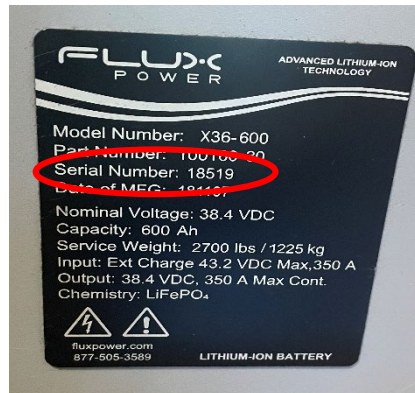
INSERT PICTURE OF ID PLATE OF AN X36

All X36 BMS 1.0 batteries w/ 1.19.110 firmware that begin with a 19**** serial number. The serial of the battery is placed on the battery's I.D. label in front of the E-tray Cover underneath the internal SOC.

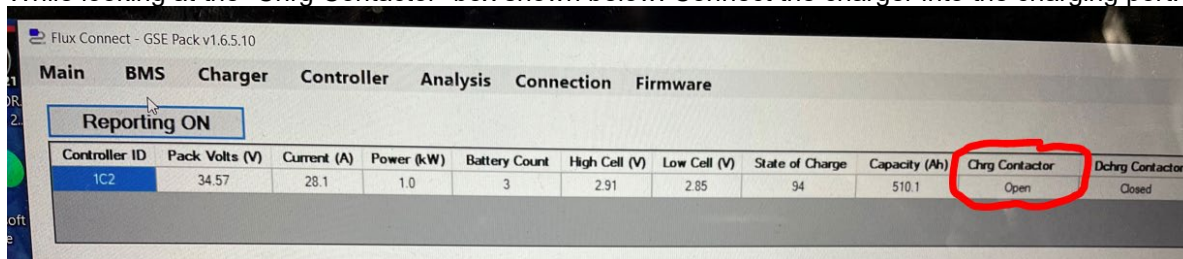
1. While looking at the “Chrg Contactor” box shown below. Connect the charger into the charging port.

2. While the charge is connected, does the “Chrg Contactor” box change from “OPEN” to “CLOSE”?
3. If it doesn’t then you have confirmed that your X36 BMS 1.0 has the Charge Contactor Lock OPEN bug.
4. If not, please call Flux Power at (877) 358-9487 or at <https://www.fluxpower.com/support> as further troubleshooting will be needed.
